1 INTRODUCTION

This case study provides an example of when traditional ecological knowledge (TEK) data were appropriately acquired and incorporated into analysis and decision-making processes.

The Saskatchewan Research Council (SRC) manages 37 former uranium mining sites in northern Saskatchewan. On one of the larger sites, the former Lorado Mill site, traditional knowledge was used in support of scientific assessments to successfully create a revegetation plan overlying the engineered tailings cover system.

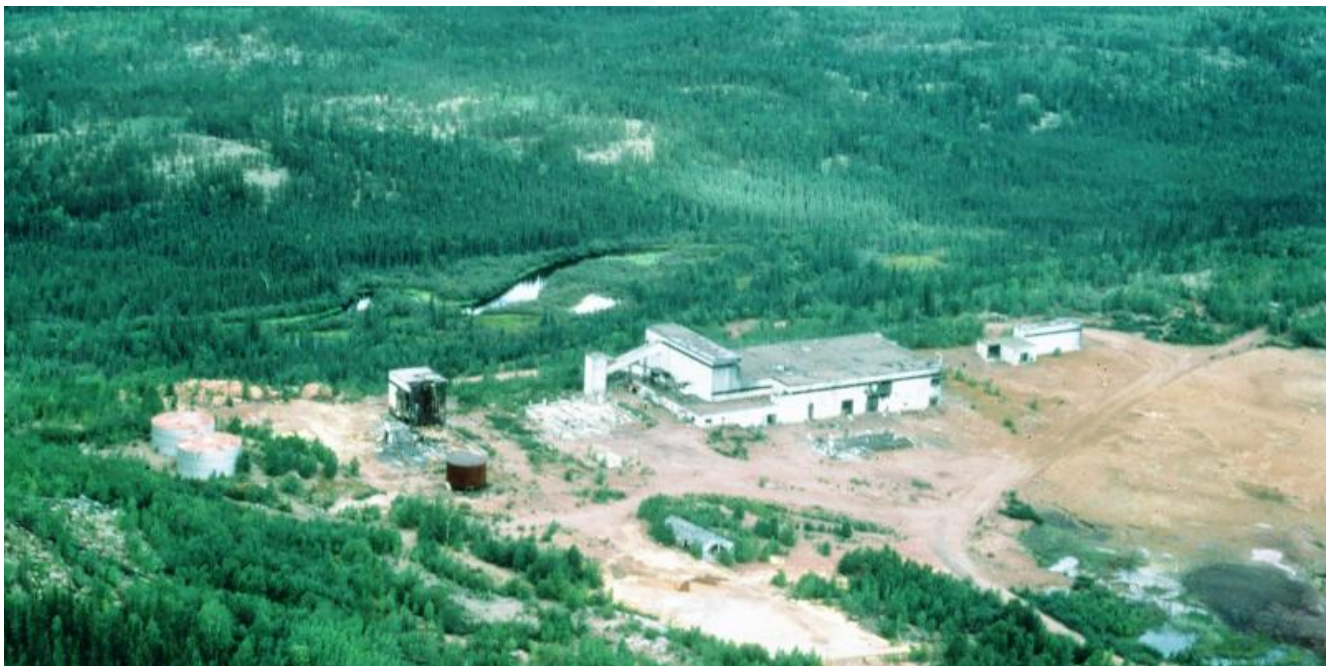
Figure 1. Aerial photo showing the former Lorado Mill facility and tailings area circa 1980.

The former Lorado uranium mill site is located approximately 8 kilometers south of Uranium City, Saskatchewan. The mill operated from 1957 to 1960 (Figure 1). Tailings were deposited adjacent to Nero Lake, with some flowing into the lake. Estimates of the amount of ore processed at the mill range from 305,000 to 545,000 tons. The volume of tailings produced is estimated to be 227,000 cubic meters, of which 50,000 cubic meters lie within Nero Lake. The exposed tailings cover approximately 14 hectares (Figures 2 and 3).

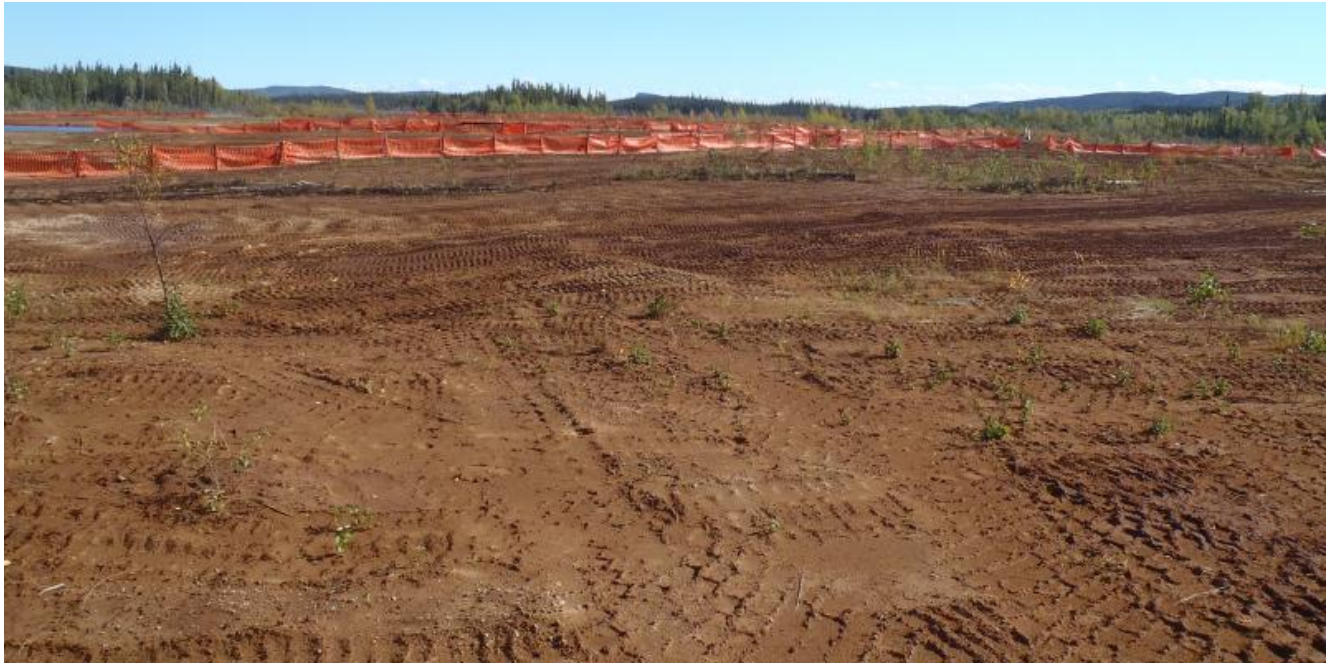
Figure 2. The Lorado Mill tailings area with wind fencing in 2011.

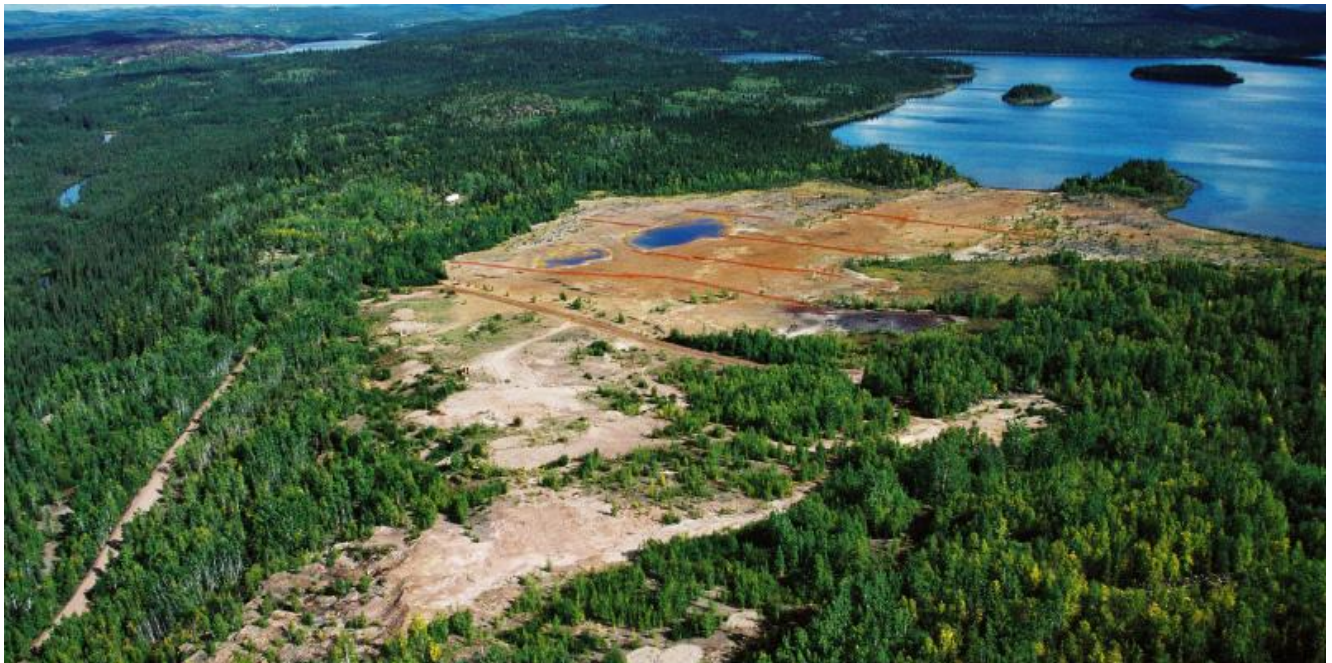
Figure 3. Aerial photo showing the Lorado Mill footprint with wind fencing (with structures removed and tailings area) in 2008.

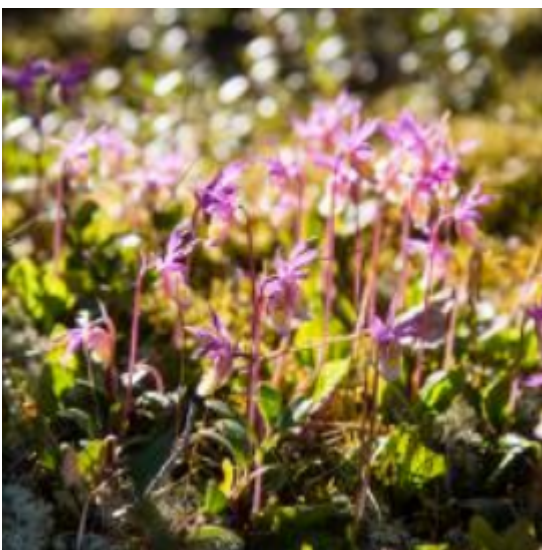
Figure 5. Example of vegetation established on the cover of the Lorado Mill tailings.

SRC used a combination of the scientific and traditional knowledge it acquired to create a site-specific revegetation prescription. Three years after the implementation of the prescription, the vegetative cover that has established on the engineered tailings cover system has been very successful (Figure 5). The results of this successful cover have saved the project thousands of dollars (versus the use of geosynthetics), allowing for the quicker re-establishment of the ecosystem (more diverse plant and animal communities have come back), and provided for a robust, long-term erosion control layer for the tailings cover system that is fire resistant and self-sustaining.
